AIRCRAFT SPEC SHEET

Model: A 36TC - Bonanza

Reg. No.: N36925

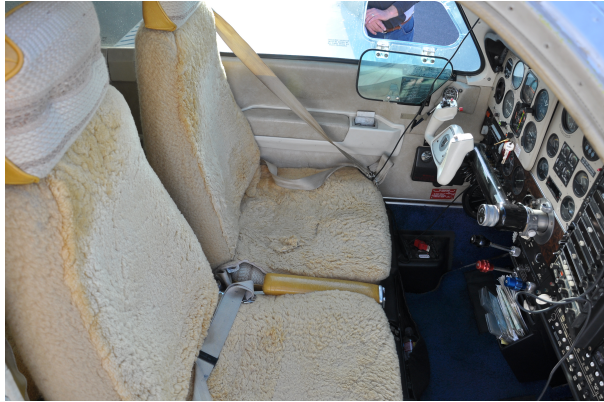
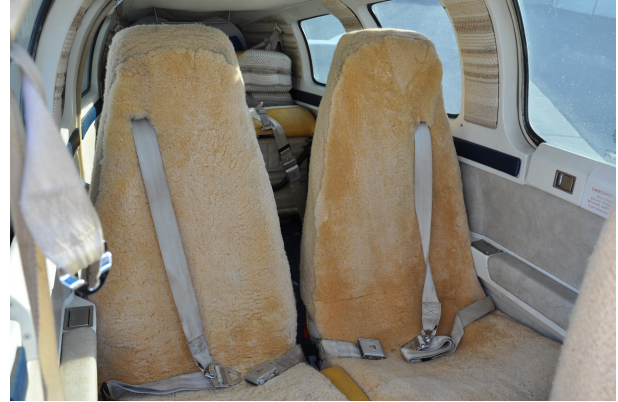
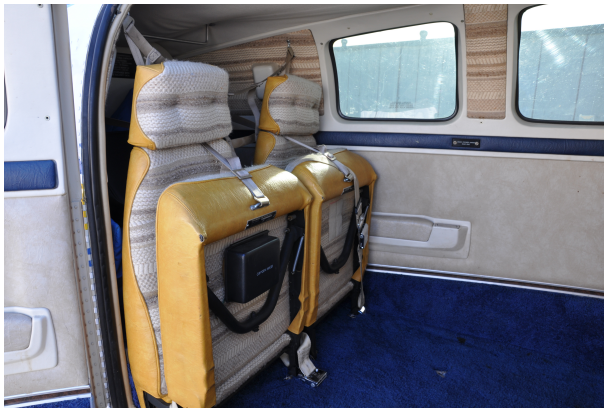
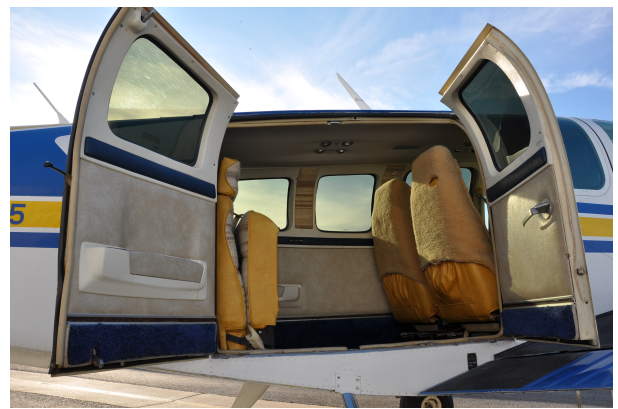
Comments: The interior is original and Seats 1, 2, 3, and 4 have sheep skin covers. The fabric appears in good condition under the seat covers. The pilots "seat cover" is worn and has a 4" tear. The 5th and 6th seats are stored in the upright position. Seats 3 and 4 are in the forward facing position and the mechanic says that they may be turned around for club seating, without difficulty. The carpet, headliner, and plastic side panels appear in good condition without tears or cracks. There are a few cracks around the pilots storm window. G & D Window Thermal Panes are installed per an STC. Provides dual pane, tinted windows, with added sound protection.

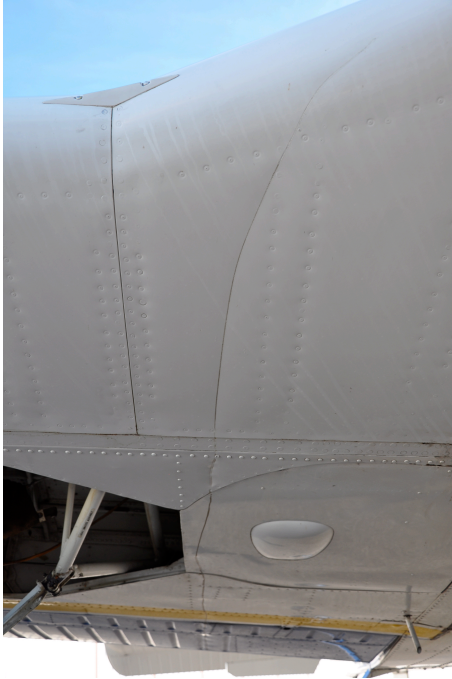
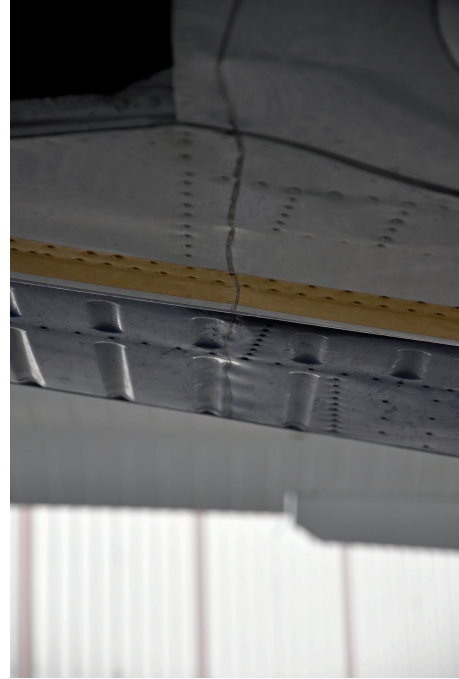
Under right wing, between fuselage and right main gear, there is a deep scratch that runs the full length, forward to aft. The AI mechanic who maintains the aircraft, believes that the aircraft ran over a taxi light or snow measurement marker that was covered by snow. It does not effect the airworthiness of the aircraft and is only noticed if looking under the right wing. A high estimate cost of the repair is \$10,000. The Repair Station that performs the work may, or may not, consider this as Damage History.

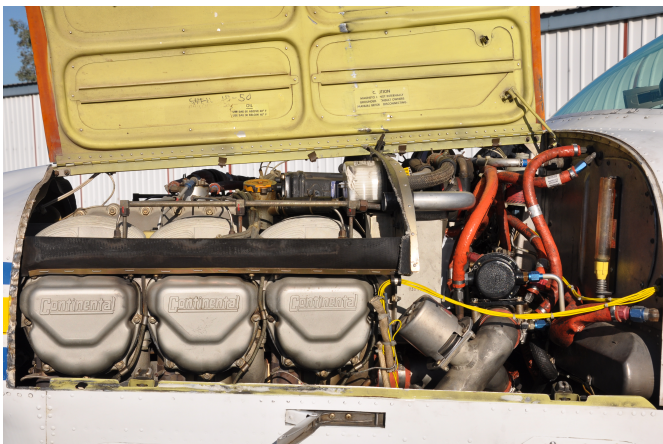
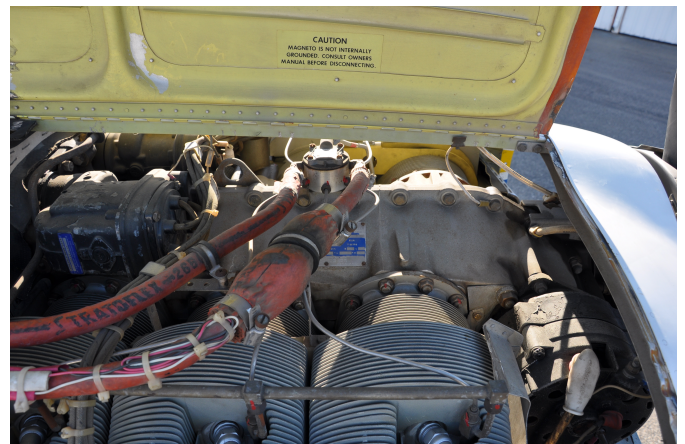
General Engine Comments: The engine was replaced with a Factory Reman in 9/87. Compressions on the last annual inspection were 72, 72, 70, 72, 70/80. The engine showed no signs of any leaks and overall looked in excellent condition.

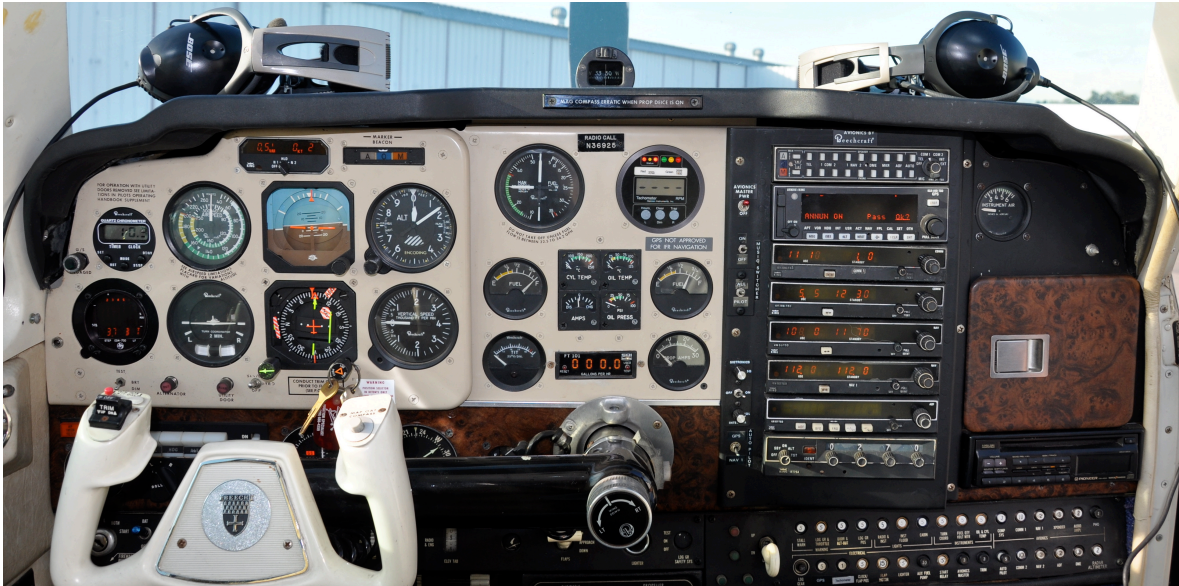
Comments: The aircraft also has Electric Trim on the yoke, Sigtronics Intercom System, Beech Digital Chronometer, an Avionics Master Switch, and a copilot Push-To-Talk switch on panel.

Comments: The avionics were ground tested and appeared to be operating normally. IFR Static and Transponder check completed 12/08. ELT Due 11/10.

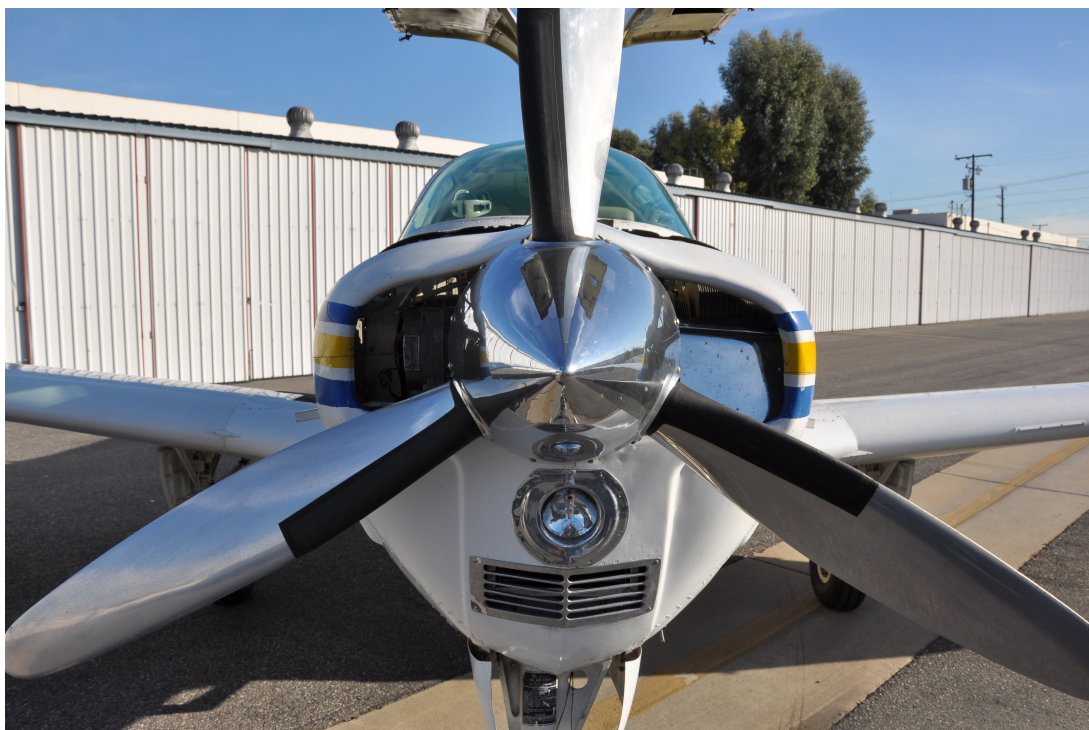
Comments: New prop de-ice boots installed during prop overhaul, 11/22/99. Not tested.
